Subject: August 29, 2017 Compliance Evaluation Inspection

**CWA COMPLIANCE EVALUATION INSPECTION REPORT
U.S. ENVIRONMENTAL PROTECTION AGENCY, REGION 5**

Purpose: Compliance Evaluation Inspection

Date of Inspection: 8/29/2017

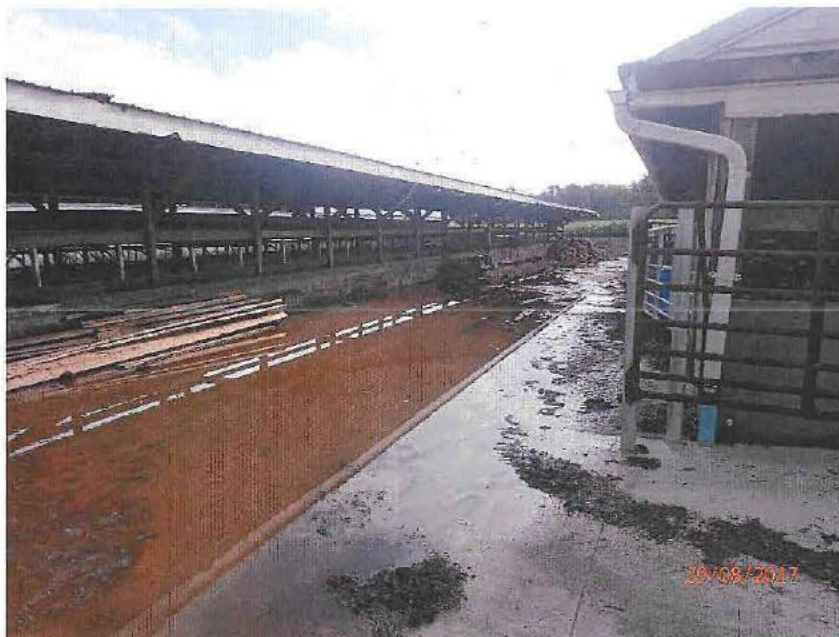
7: P8292414

Walking further north, we viewed a roofed concrete corral area between the Calves 2 Barn and the Heifers Barn. We observed manure, process wastewater, and piles of feed and bedding outside the barn doors (see photographs 7-10). According to FOIA Ex. 6 (Personal Privacy) this concrete corral area drains towards the lagoon. Water from the downspouts that were recently placed on all the barns drained to the adjacent drainage ditch (see photograph 49).

Description: Water backup on the concrete pad that leads to the lagoon.

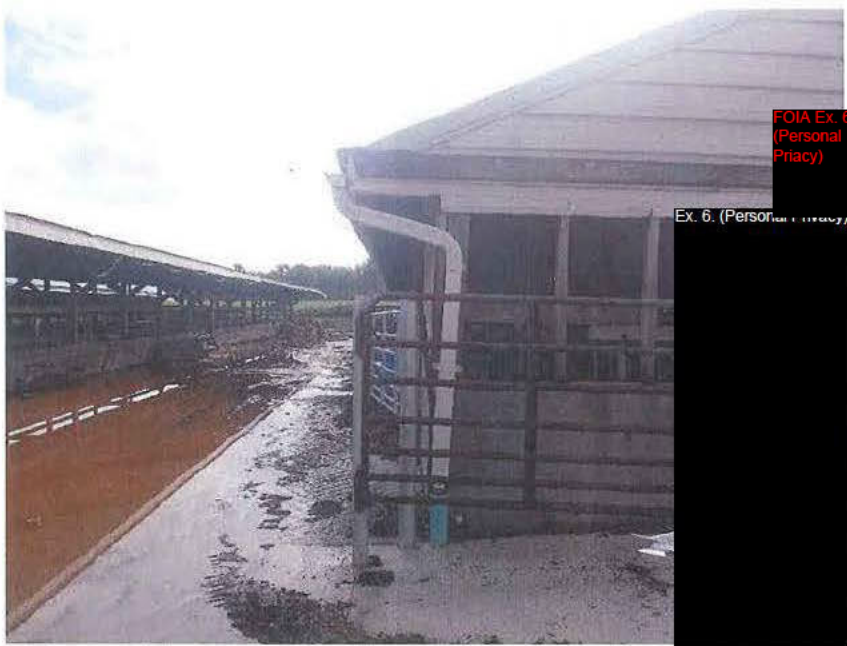
8: P8292415

Description: Solid manure outside of the Calves Barn 2. Drains towards the lagoon.

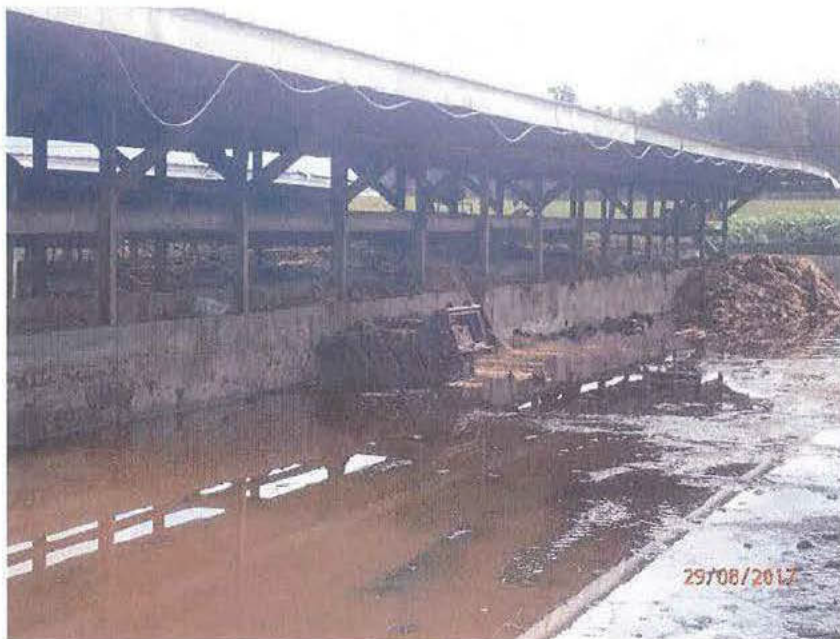
9: P8292416

Description: Solids stacked between barns.

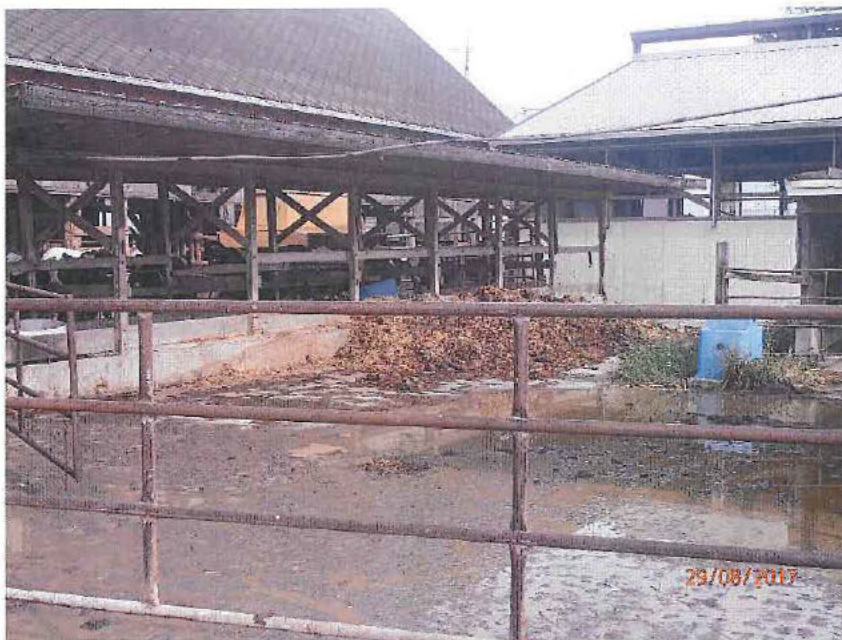
10: P8292417

Description: Solids on the side of the Heifers Barn.

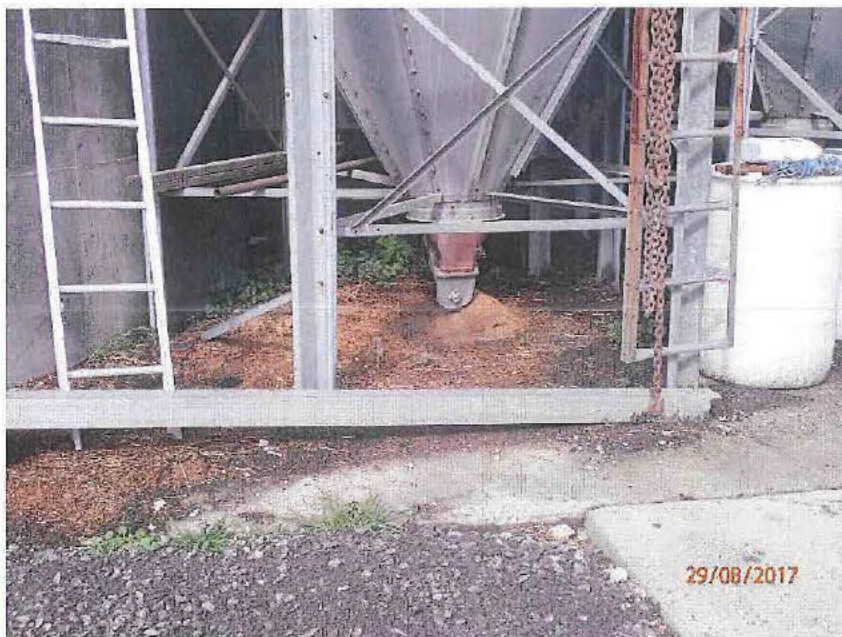
11: P8292418

Walking back south and around the silo bins, we noticed some feed spillage under the silo bins (see photograph 11). The ground slope in this area is towards the concrete pad in the corral area and ultimately towards the lagoon. We observed feed spilled below and around the silo and grain bins next to the Old Barn as well as in front of the garage (see photograph 12). This area ultimately drains north and then east towards the lagoon and the drainage ditch (see photographs 13 and 14). Between the Old Barn and the Heifers Barn, we viewed an open fenced concrete area that was sloped towards the corral that ultimately drains to the lagoon (see photograph 15).

Description: Bulk bin with spilled feed around it. .

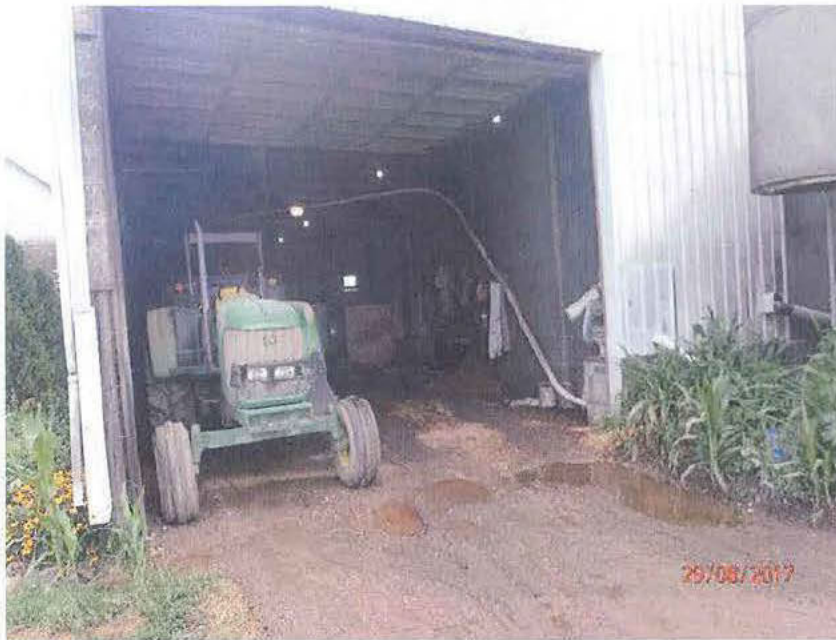
12: P8292419

Description: Pooled water and silage from cleaning the equipment in front of the garage.

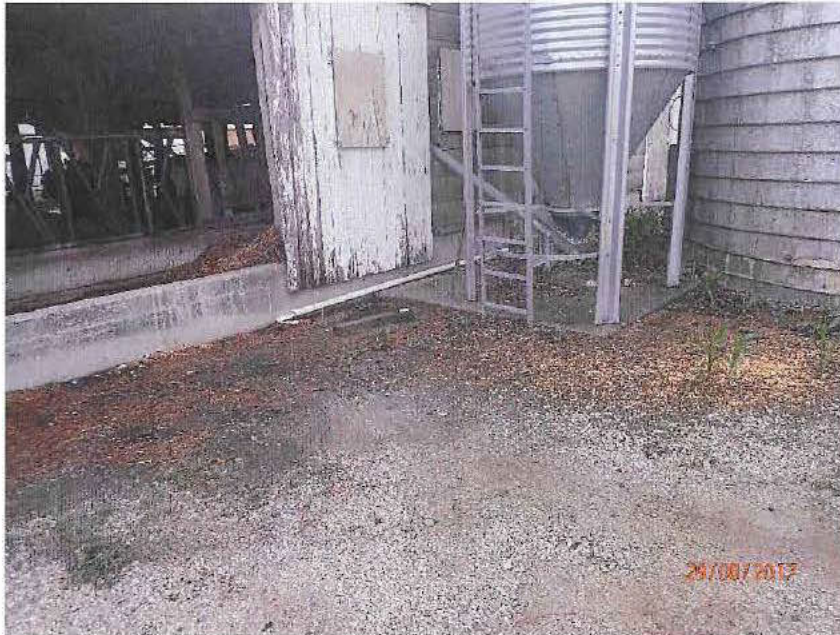
14: P8292421

Description: Spillage by silo and bulk bin west of the Old barn.

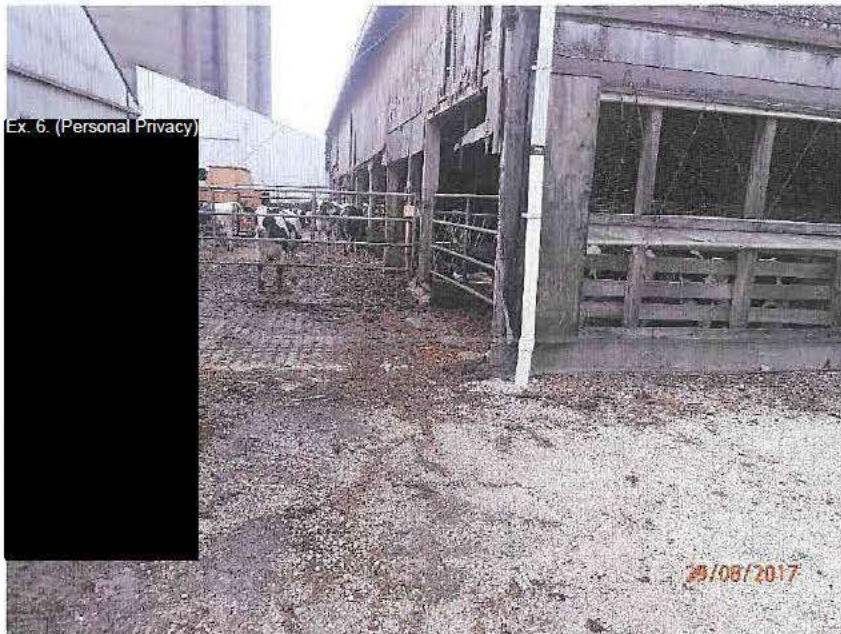
15: P8292422

Description: Concrete pad between Old barn and the Heifers barn.

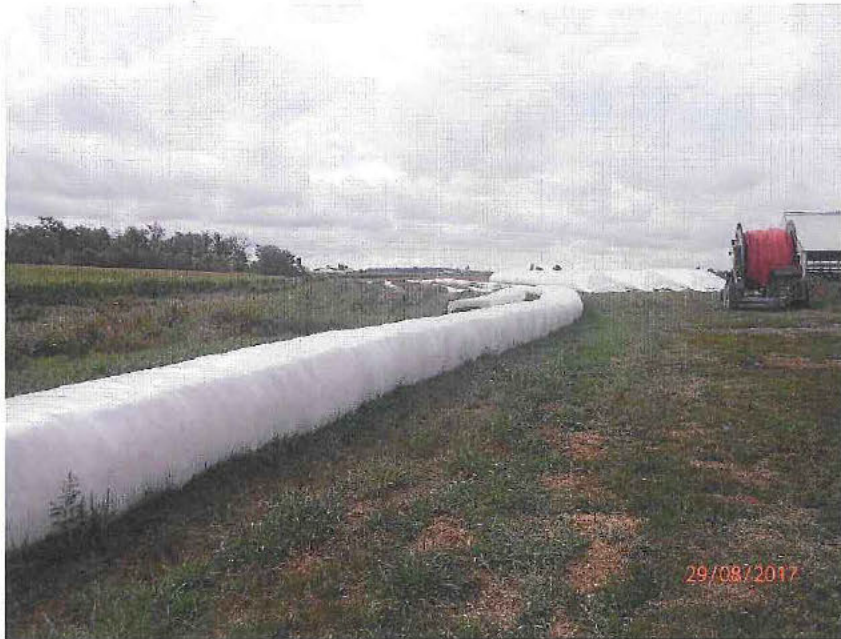
22: P8292429

EPA observed three rows of haylage bags between the lagoon and the drainage ditch (see photographs 22, 28, 40, and 41). Two of the bags were open to precipitation and process wastewater. Based on the topography, this area drains toward the ditch (see photographs 42 and 43). During the inspection, no process wastewater was flowing from the haylage bags towards the ditch. The drainage ditch was covered in vegetation at the time of the inspection and we observed a small amount of flow and a depth of water of approximately 0.5 ft in it at the time of the inspection (see photographs 23 and 24).

Description: Haylage bags along the waterway. Bags are place approximately 20ft from the waterway.

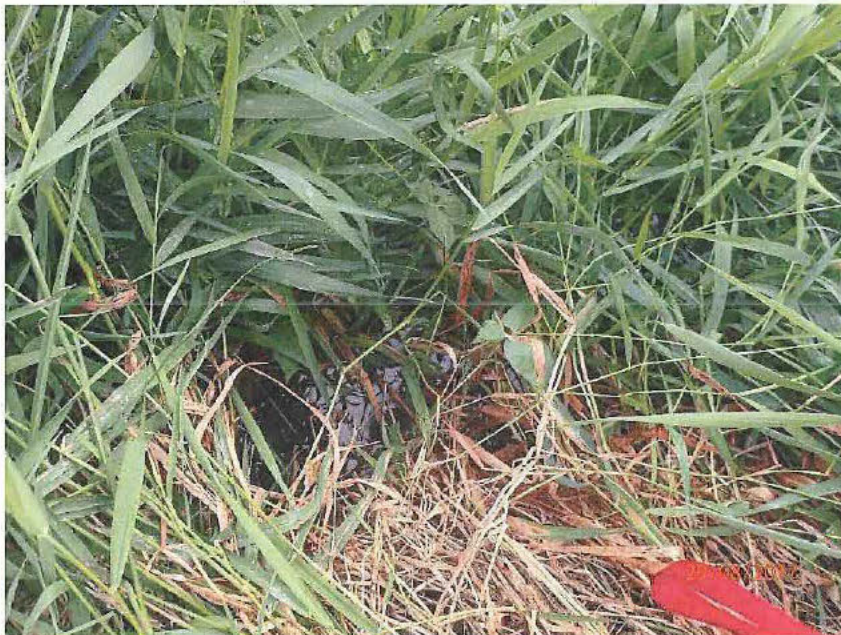
23: P8292430

Description: Approximately 0.5ft of water in the waterway on the east side of facility.

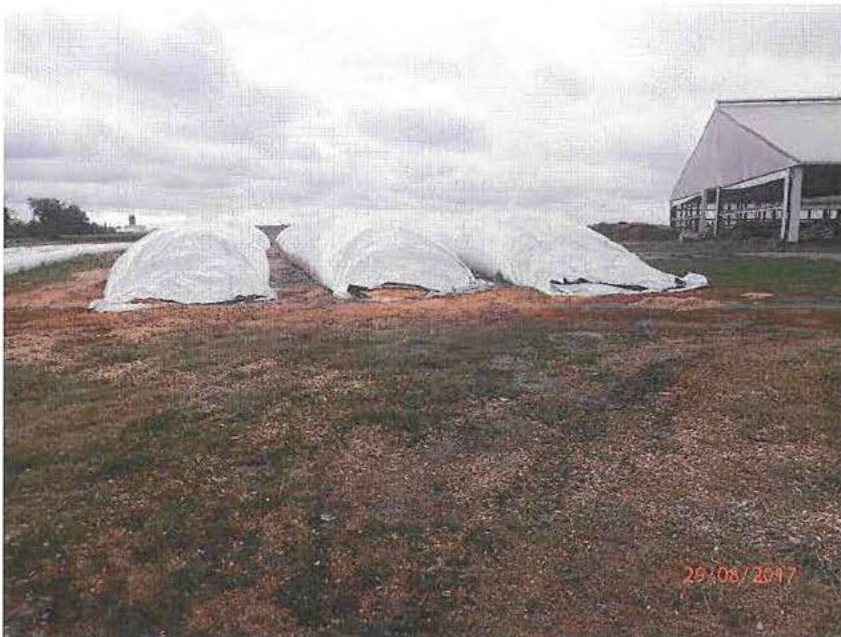
27: P8292434

Near the haylage bags and on the east side of the Dairy Cow Barn, we observed three silage bags (see photographs 27 and 28). Ex. 6. (Personal Privacy) stated these bags had recently been filled. We observed silage on the ground (see photograph 29) and browned/yellow vegetation around them. Ex. 6. (Personal Privacy) stated that the vegetation was discolored because of a gas coming out of the silage bags that would burn and discolor the vegetation around them. Based on our observations of the topography in this area, it drains towards the ditch.

Description: Recently filled bags of silage.

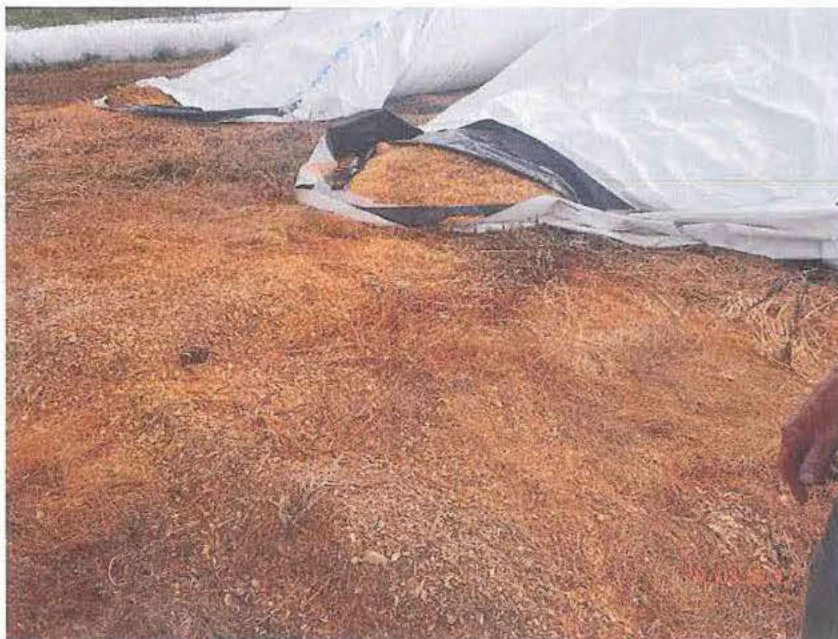
29: P8292436

Description: End of silage bags where nitrogen gas coming out of them had turned the grass yellow. There was also spilled silage around the bags and bag openings.

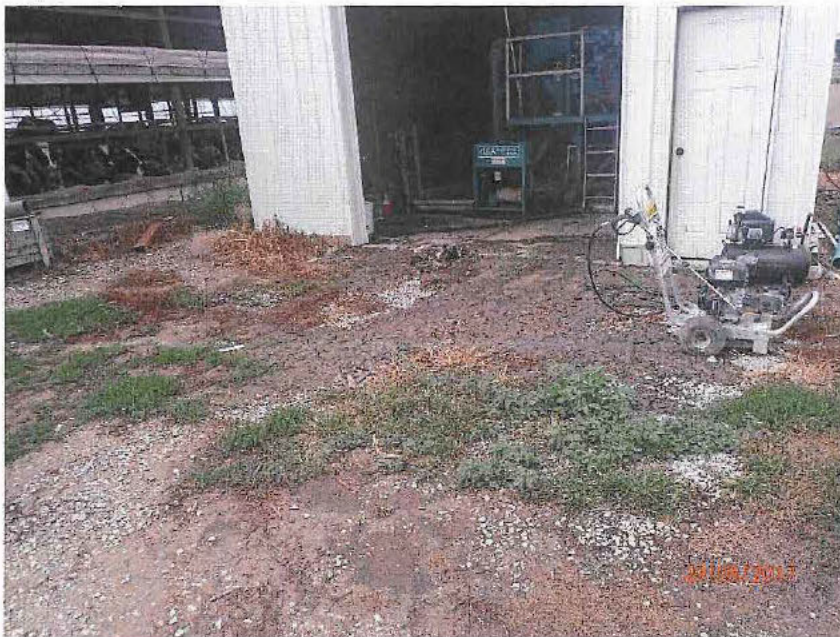
31: P8292438

Description: Manure ran out of the Manure Press barn when the pit became so full.

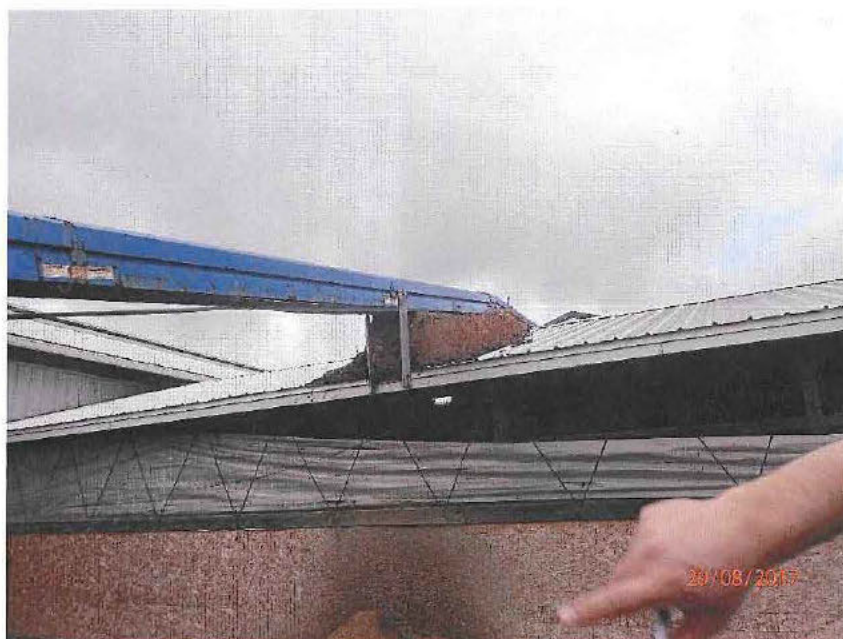
35: P8292442

Description: Solids from the press belt accumulated over a year's time.

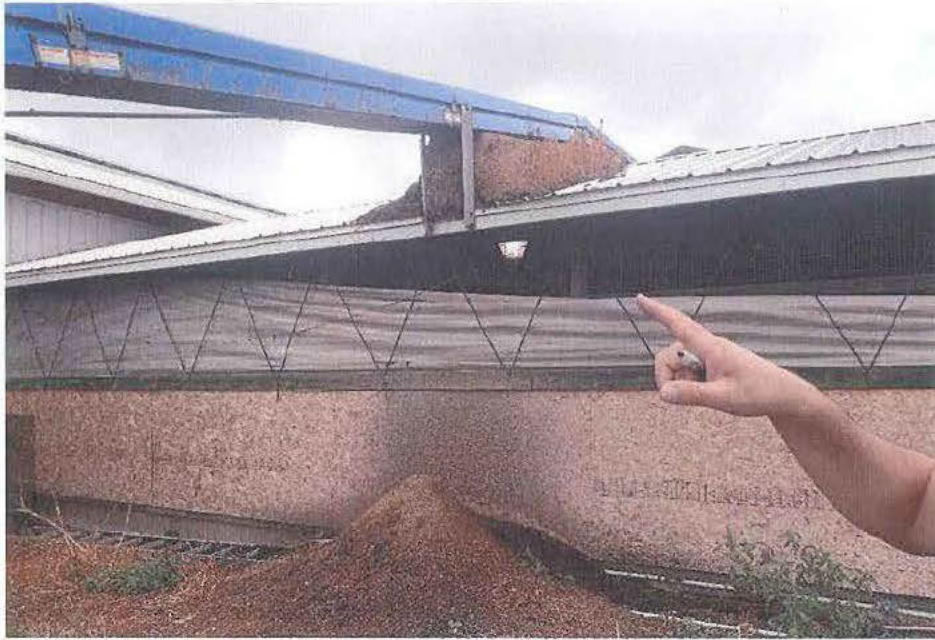
36: P8292443

Description: A years worth of solids buildup from the press belt. Pile of manure is open to precipitation.

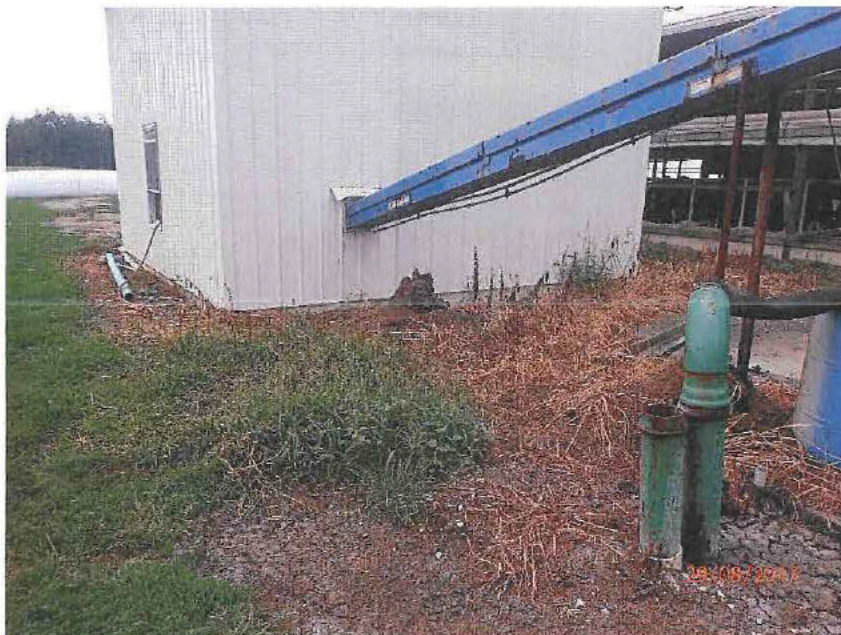
39: P8292446

Description: Small pile of solids which fell off the belt from the Manure Press barn.

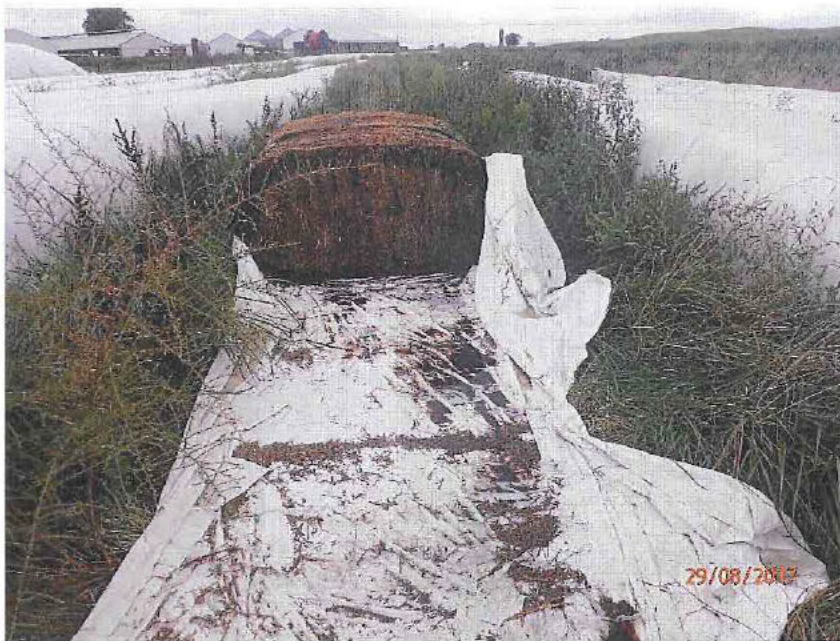
42: P8292449

Description: Open hay/straw bag. Hay is spoiled and will be land applied.

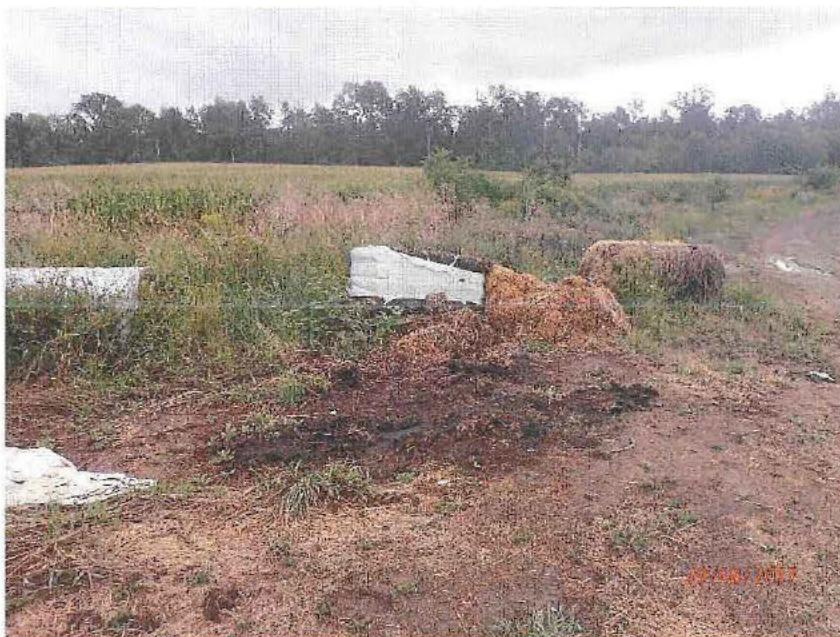
43: P8292450

Description: Open hay/straw bag close to the waterway.

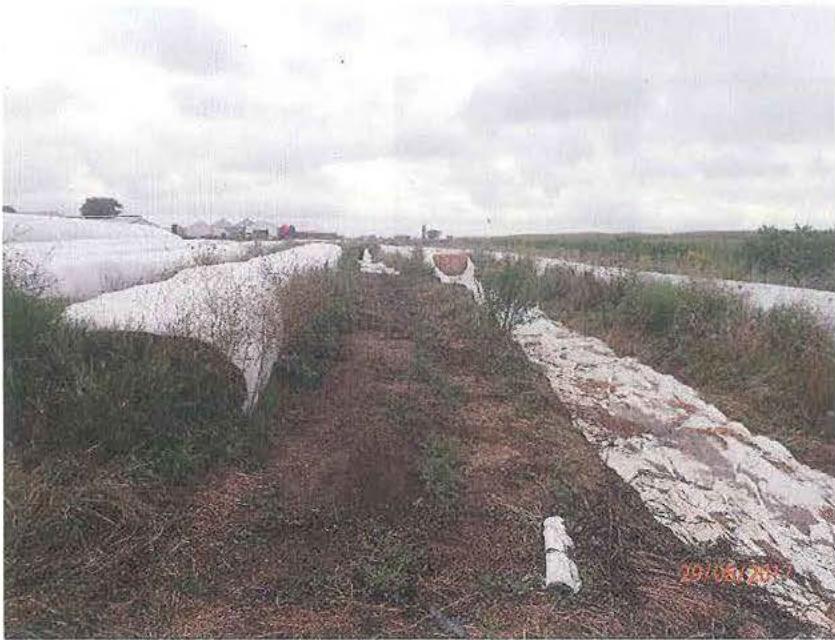
44: P8292451

Description: Wrapped wheat bags close to the waterway.

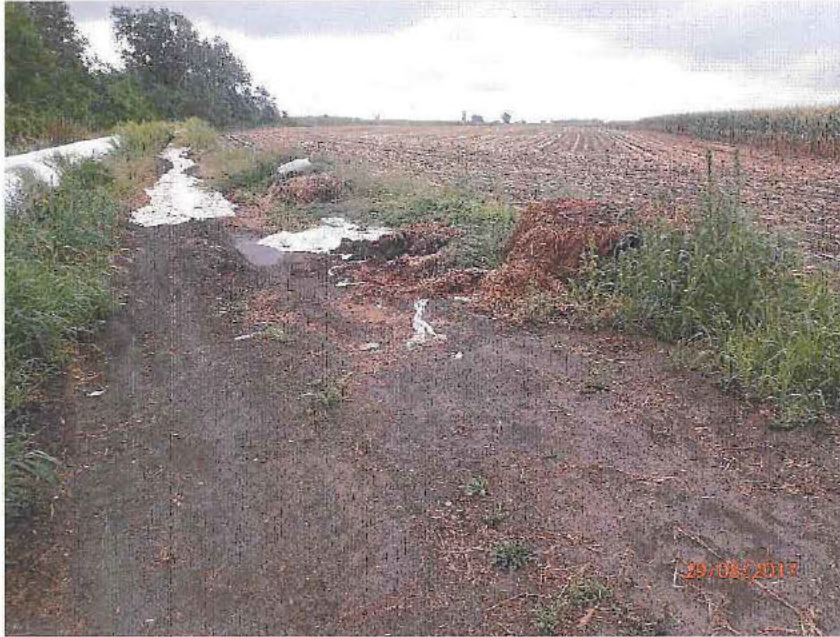
46: P8292453

Description: Open bag of wrapped wheat close to the waterway.

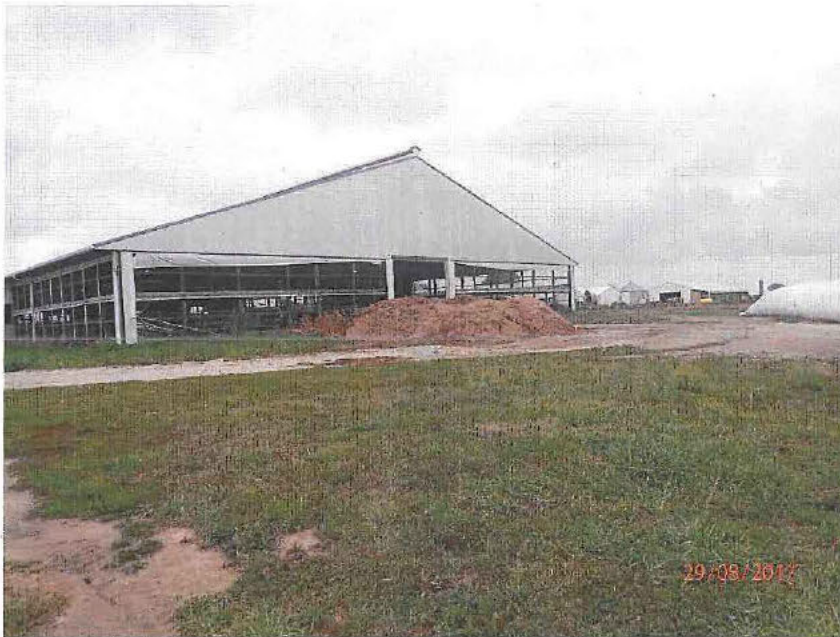
47: P8292454

On the east end of the Dairy Cow Barn, we observed a pile of leftover silage from the Dairy Barn (see photographs 47 and 48). In this area, the ground slopes from the leftover silage pile towards the drainage ditch.

Description: Leftover/uneaten silage stacked and waiting to be hauled on the east end of the Dairy Cows barn. Stack is open to precipitation.

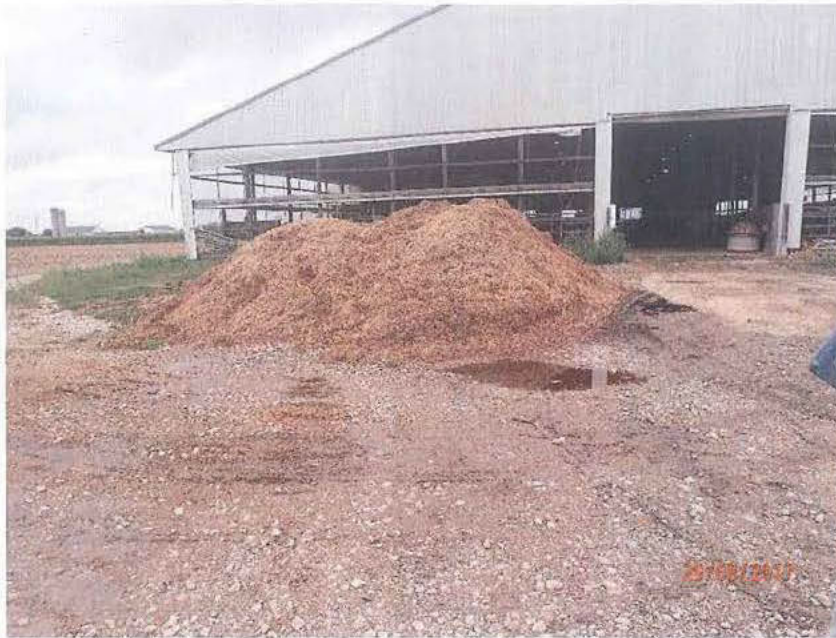
48: P8292455

Description: Leftover/uneaten silage stacked on the east end of the Dairy Cows barn and waiting to be hauled..

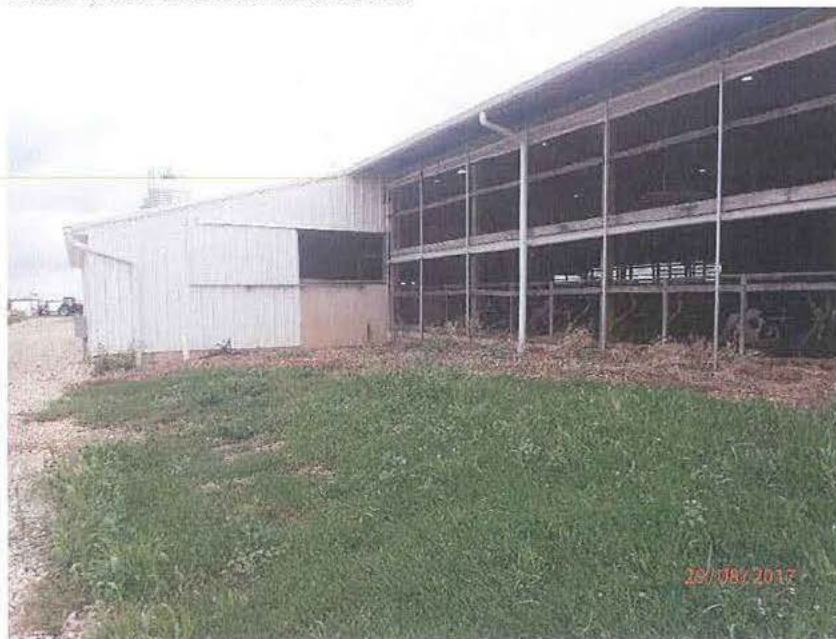
49: P8292456

Description: New downspouts on the south side of the Dairy Cows barn that end up in the ditch.

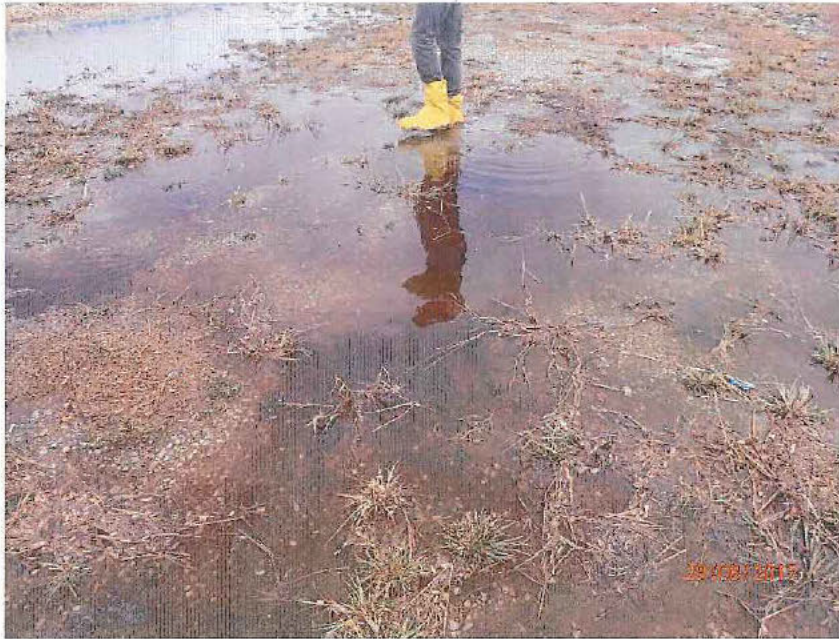
82: P8292489

Description: Pooling water between the silage on the west side and the Dairy Cows barn. This area drains towards the corn field on the south of the facility.

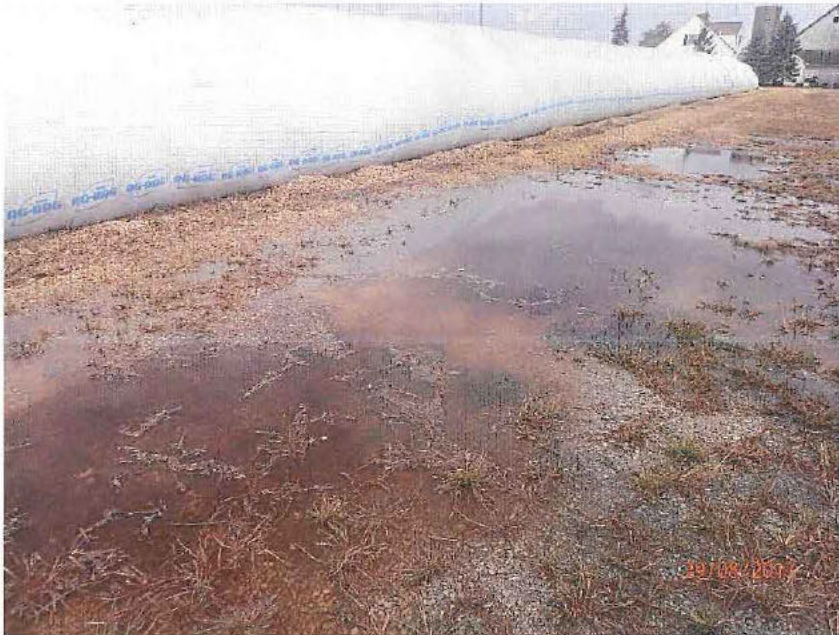
83: P8292490

Description: Pooling water next to the silage bags on the west side. Discoloration is silage leachate in the precipitation water.

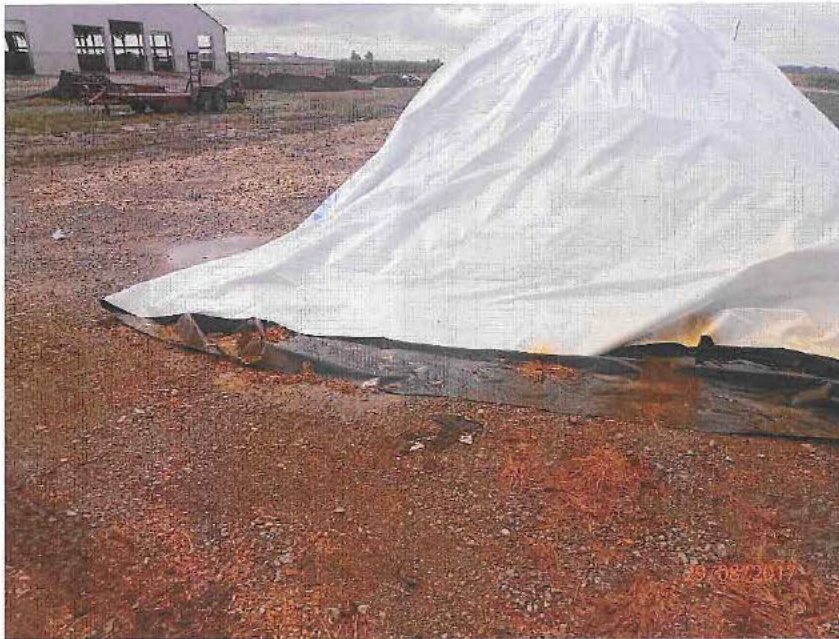
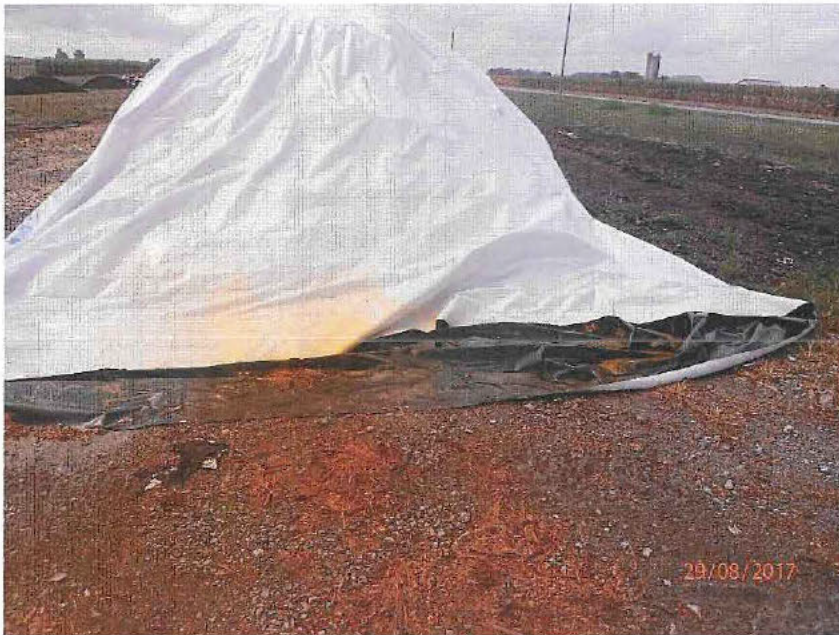
At the open end of the Silage bags, we again observed some brown/yellow gas coming out of the bags and took two videos of the gas (see photographs 88-92). We then walked to the composting barn where some of the solids from the barn were open to precipitation and could generate runoff of manure or process wastewater (see photographs 93-97). The walkthrough ended at the Calves 1 Barn where the milking tanks are located (see photographs 98-100). Any spilled process wastewater from this area collects in the floor drains and ultimately drains to the lagoon.

Description: Brown nitrogen gas coming out of recently filled silage bag.
